Home Inspection Report

1234 Any street, Hometown, USA

Inspection Date:
02/04/2005

Report Number:
C050204-1

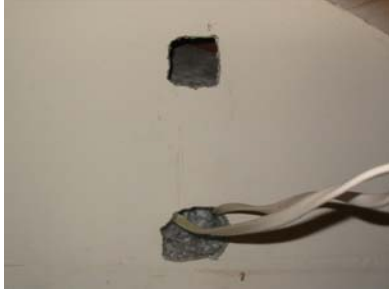
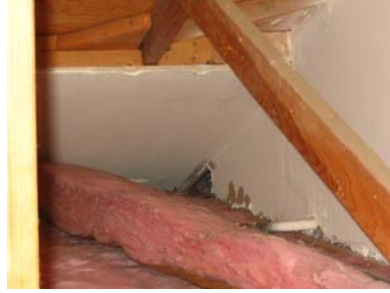
Garage

Safety Issue: Proper fire separation between the garage and house proper is recommended (holes in fire wall).

- **Repair, Safety Issue:** Proper fire separation between the garage and house proper is recommended (holes in fire wall).

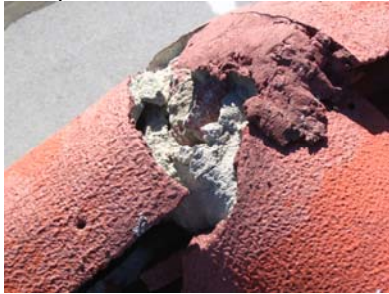
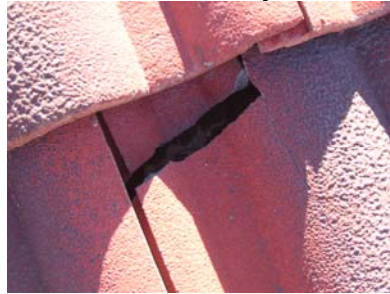
Sloped Roofing

Repair: Minor repairs to the roofing are needed. Damaged or missing roofing material should be repaired. All roof penetrations should be examined and sealed as necessary.

- **Repair:** Minor repairs to the roofing are needed. Damaged or missing roofing material should be repaired. All roof penetrations should be examined and sealed as necessary.

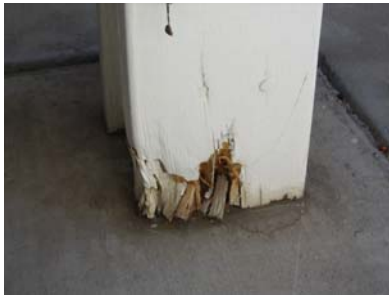
Porch / Deck Cover

Repair: The support posts for the deck/porch cover showed evidence of deterioration. Refer to termite report for further information.

- **Repair:** The support posts for the deck/porch cover showed evidence of deterioration. Refer to termite report for further information.

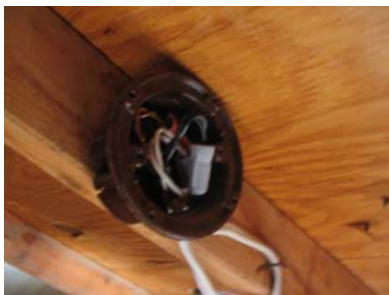
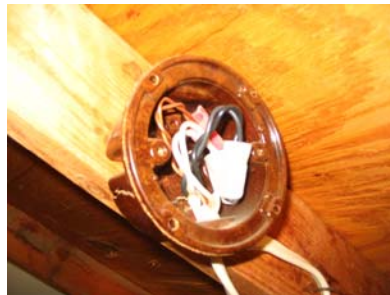
Distribution Wiring

Repair: All junction boxes in the garage attic space should be fitted with cover plates, in order to protect the wire connections.

- **Repair:** All junction boxes in the garage attic space should be fitted with cover plates, in order to protect the wire connections.

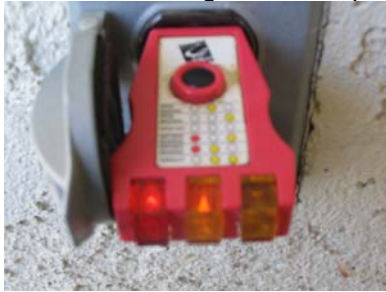
Repair: An outlet at the front exterior has reversed polarity (i.e. it is wired backwards). This outlet and the circuit should be investigated and repaired as necessary.

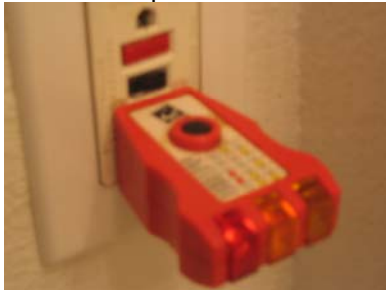
Repair: A ground fault circuit interrupter (GFCI) outlet is inoperative and has reversed polarity. This circuit should be repaired.

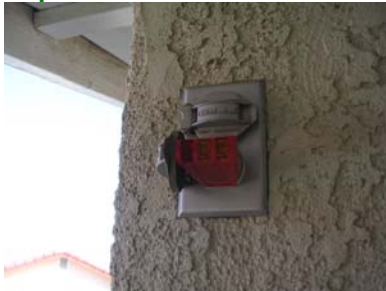
Repair: The outlet at the left front near the eave was inoperative at the time of the inspection.

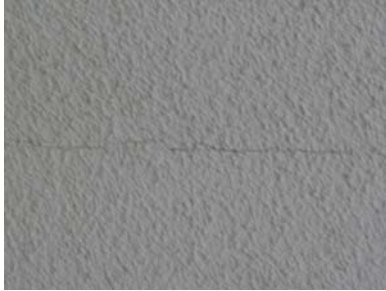
Exterior Walls

Monitor: Common minor cracks were observed on the exterior walls of the house. This implies that structural movement has occurred. The location, size, shape of these cracks is common. The inspection did not find evidence of significant movement requiring immediate major repairs.

- **Monitor:** Common minor cracks were observed on the exterior walls of the house. This implies that structural movement has occurred. The location, size, shape of these cracks is common. The inspection did not find evidence of significant movement requiring immediate major repairs.

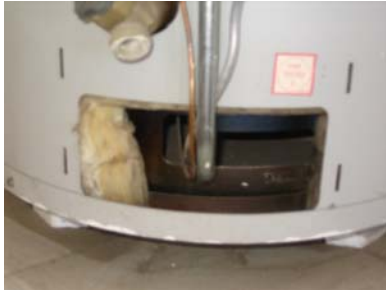
Water Heater

Monitor: The water heater was missing its cover at the time of the inspection.

Monitor: The water heater was missing it's cover at the time of the inspection.

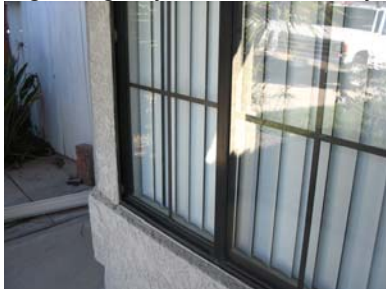
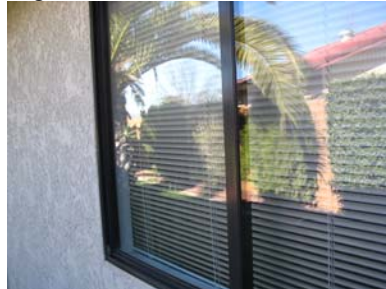
Windows

Monitor: It may be desirable to replace window screens where missing. The owner should be consulted regarding any screens that may be in storage.

- **Monitor:** It may be desirable to replace window screens where missing. The owner should be consulted regarding any screens that may be in storage.

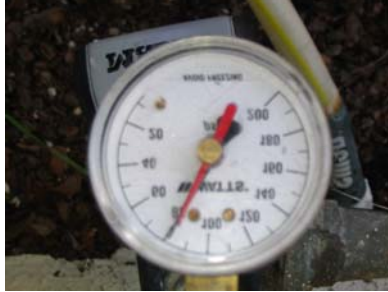
PSI @ 80 Lbs.

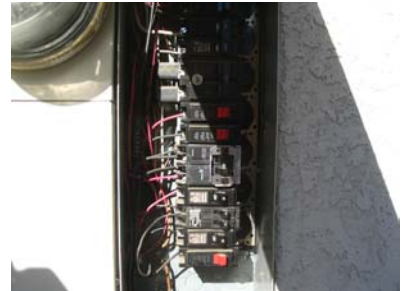
Electrical panel in good order

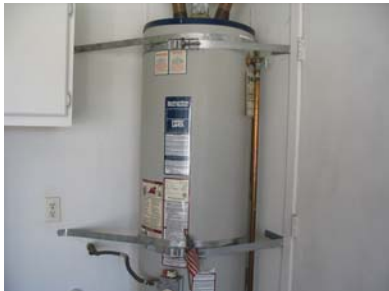
Water heater properly strapped
